# Condenser condition assessment in a thermal power plant: A comprehensive case study for performance optimization

World Journal of Advanced Engineering Technology and Sciences, 2024, 13(02), 390–399

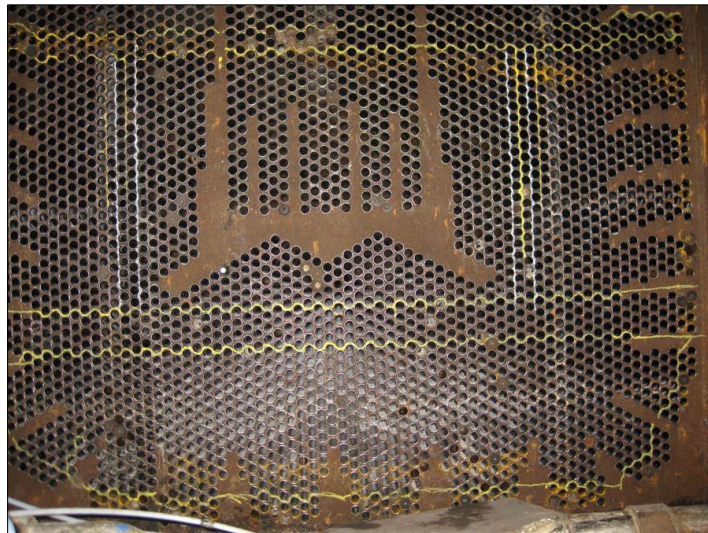
The condenser unit under consideration has been in operation since 1987, as a base load station in southern Michigan, USA. The capacity of this unit is approximately 290 MW with a pressure and temperature of 1950 psi and 1005° F, respectively, at the superheater outlet. The unit, as well as the condenser, has been in operation for the last 37 years. A major rebuild took place in 2013 and included partial retubing (top 5 rows) of the condenser. Since early 2024 the condenser has been experiencing a series of tube failures. In the 2024 calendar year to date 55 tubes were plugged in. So far 411 tubes have been plugged in. The condenser, as shown in Figure 1 has a total of 12,130 tubes which means approximately 3.40% tubes are plugged. Since August 10, 2024, when the last tube plugging was done, the sulphate concentration at the condensate extraction pump (CEP) discharge remains steady and there appears to be no further evidence at this time of any remaining tube leakage.

**Figure 1** The lower quadrant of the condenser

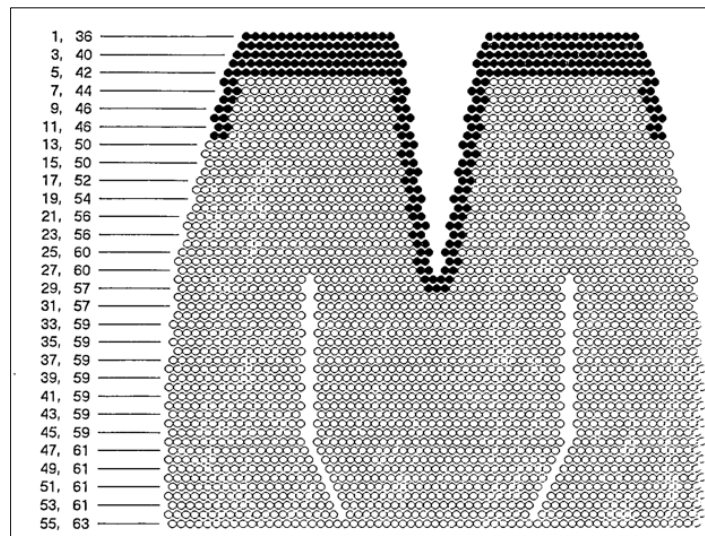
**Figure 2** Condenser tubesheet map

The tubes previously tested as “good” (0-20% wall loss), which are now plugged as highlighted in the above comparison. Both 2012 and 2020 reports showed that these tubes were in “good” condition, which was 93.5% and 98.5% of the sample respectively. The defective tubes percentage was high in the 2012 test as compared to the 2020 test because the top five tube rows (severely affected area during 2012 test) were retubed in 2015 and most of the defective tubes were replaced. This table shows that in the last 14 years, 54 previously good tubes are now plugged in. In the last 5 years 29 previously good tubes are now plugged in. This demonstrates an increased rate of “good” tube degradation in the condenser condition from 2012 as the rate of “good” tube failures is increasing. This accelerated failure rate is typical for a condenser of this vintage. These plugged tubes are randomly distributed throughout the condenser, so the issue is not localized.

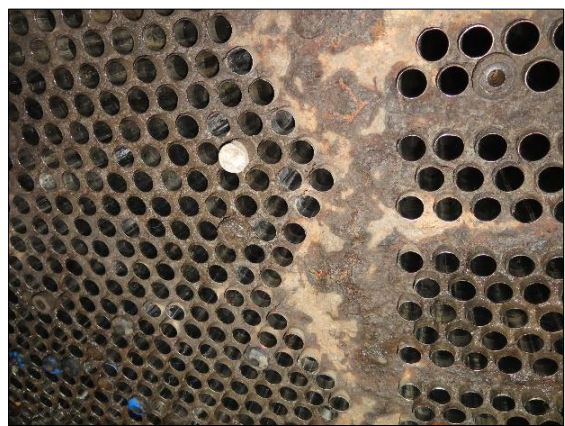
It is worthwhile to mention that partial retubing of the condenser took place in 2015. Two past NDE report along with these retubing information were utilized to estimate remaining life and complete a condition assessment of the condenser at this stage. The repair history is shown in Table 3 and picture of plugged tubesheet is shown in Figure 3.

**Figure 3** Plugged tubesheet face

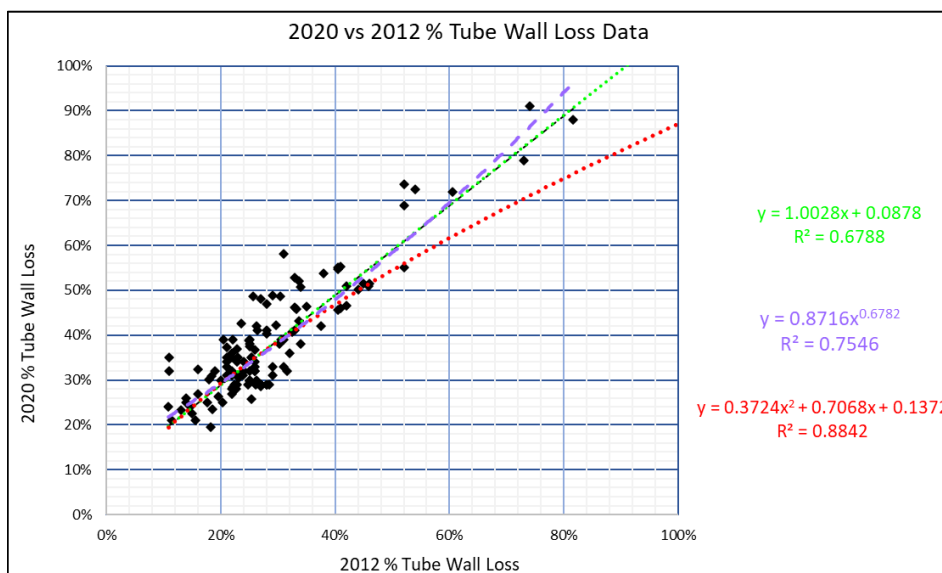
**Figure 4** Projection of tube wall loss using two consecutive eddy current test data

The power degradation growth model has higher R-squared value compared to polynomial model and therefore used in the current analysis. Using the projected wall loss, it is estimated that out of 12,130 condenser tubes, approximately 960 tubes will approach 60% wall loss by 2027, including those that are already plugged. This represents about 8% of the total tubes, which could significantly impact the condenser's ability to remove heat from the system.
