## Case study of bearing capacity failure in a 4-story reinforced concrete building

World Journal of Advanced Engineering Technology and Sciences, 2024, 13(01), 892–898

This case history analyzes the bearing capacity failure of a 4-story reinforced concrete building in Benghazi, Libya, constructed in Fall 2000. The building has a plan area of 65 m<sup>2</sup> and is supported by an 80 cm thick raft foundation resting on collapsible sandy loess, which can lose shear strength when wet.

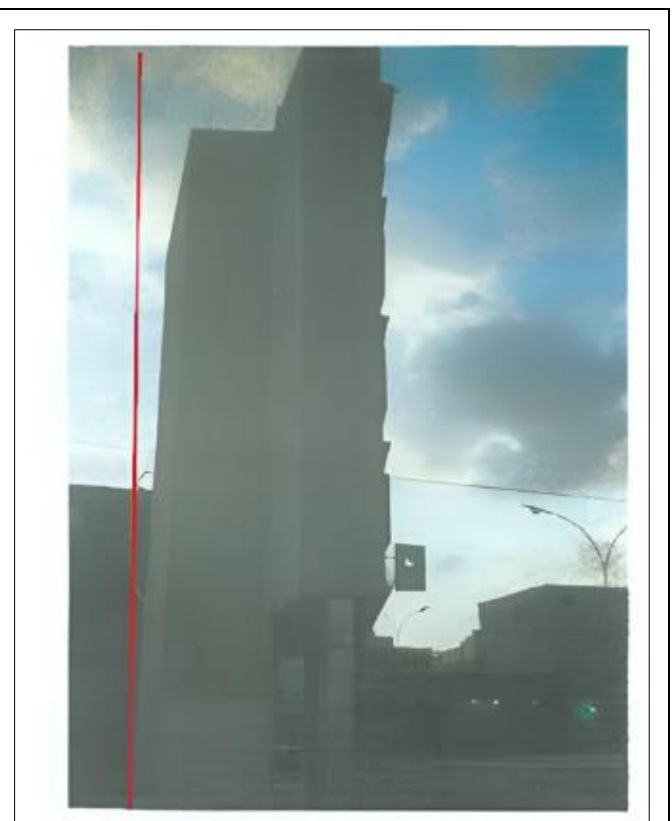
Figure 3 General view of the building after tilt

Despite a significant tilt towards the north, a detailed inspection of the structure revealed no visible cracks or deformation. This resilience is attributed to the building's rigid foundation and well-designed reinforced concrete facade walls, which allowed for rotation without excessive stress on the superstructure.

Moreover, the slenderness shape of the building and the asymmetry of the raft foundation increases the overturning moment, reducing stability and making it more vulnerable to potential overturning events. This precarious situation required immediate action to ensure safety, especially while awaiting further evaluation or demolition.

To address the instability, 100 kN of sandbags were evenly placed on all floors, particularly on the south side, to help mitigate the tilt and improve stability. The building was also continuously monitored using surveying equipment to detect any additional movement, ensuring the safety of nearby personnel until a decision about demolition could be reached. This proactive strategy underscores the significance of thoughtful weight distribution and ongoing monitoring in managing compromised structures.

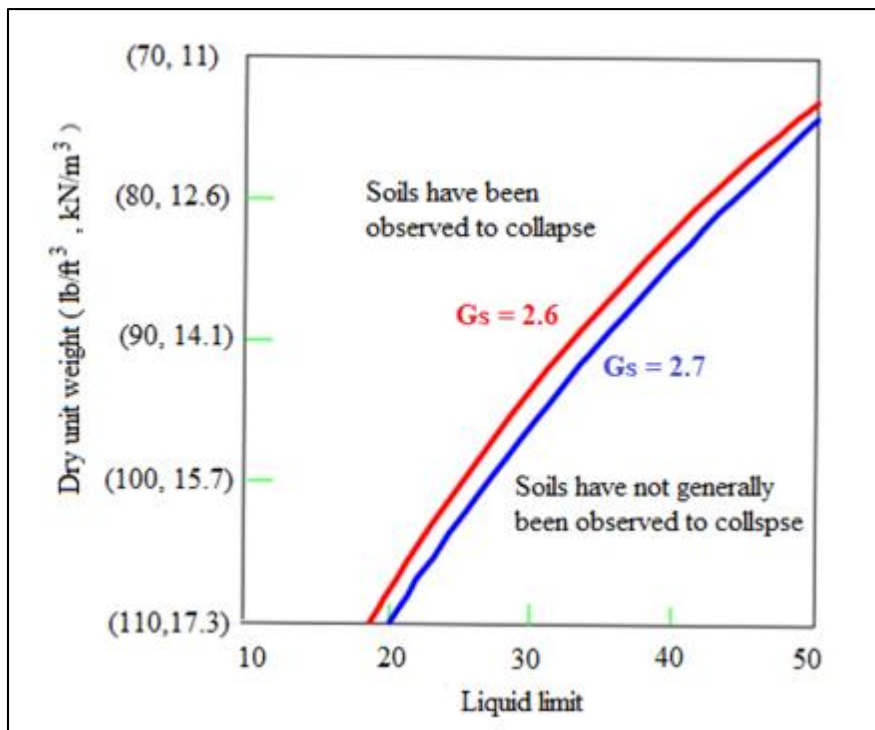
**Figure 4** Collapsible and non collapsible loess

Collapsible soils, like the aeolian loess in this region, are particularly susceptible to instability when saturated or disturbed, characterized by low plasticity and low dry densities. In dry conditions, they exhibit reasonable strength. A graph illustrating the relationship between limiting dry unit weights and liquid limits aids in identifying collapsible soils. If a soil sample's natural dry unit weight is below the limiting line, it is likely collapsible. This understanding is crucial for predicting construction issues and ensuring structural stability.

Fig 5 displays a graph of limiting dry unit weights plotted against their corresponding liquid limits. For any given soil, if the natural dry unit weight is below the limiting line, it is likely to be collapsible, as noted by Holtz and Hilf [4]. The chart clearly indicates that the supporting soil can be classified as collapsible based on its characteristics.
